June 28, 2019  
File No. 262018.063

Subject: Department of Natural Resources Washington Geological Survey,  
School Seismic Safety Assessment Project, Contract No. AE 410 -  
Seismic Evaluation for **North Beach School District**

### **School Buildings Evaluated in the North Beach School District**

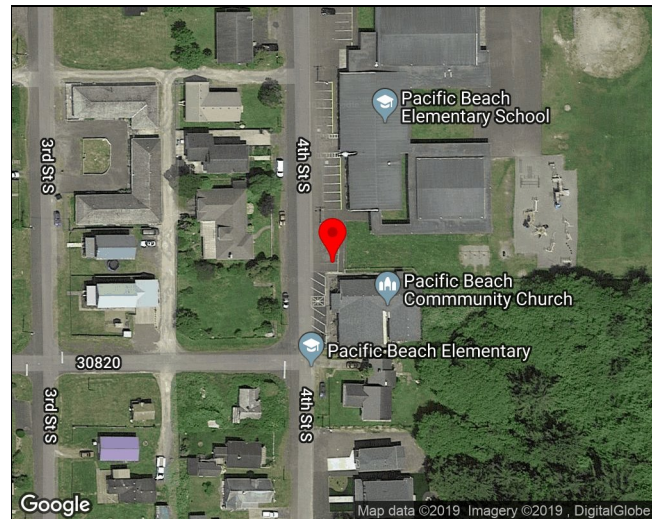
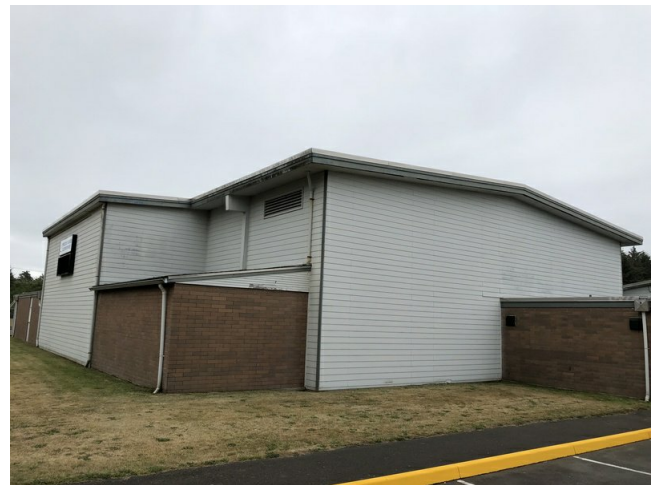
The Gymnasium Building at Pacific Beach Elementary covers a footprint of 105 feet x 90 feet and approximately 9,500 square feet. The Gymnasium is a wood-framed roof structure with wood sheathing on timber and heavy glulam beams spanning to brick masonry and wood bearing walls. Original drawings of the building structure were not available, but the structural description is based on a brief walk through. Foundations are probably conventional concrete spread footings. Lateral forces are resisted by a combination of wood and brick masonry shear walls.

<b>Structural System</b>	<b>Description</b>
Structural Roof	Fair, obviously weathered but no major damage was observed
Structural Floor(s)	Good. No major damage observed in the slab-on-grade
Foundations	Good no settlement observed
Gravity System	Roof structure appeared to be in good condition.
Lateral System	Exterior brick walls are weathered, mortar is loose in many locations and several cracks were observed. At a few locations the brick was missing or damaged.

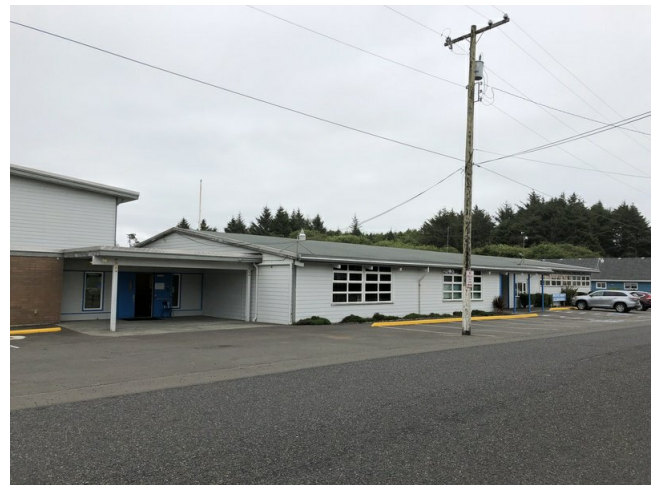
The Pacific Beach Elementary Main Building is a classroom building with a footprint of 140 feet by 70 feet and approximately 9,000 square feet. The Main Building is a single-story building with wood sheathing (decking of plywood) on timber roof joists and heavy glulam beams supported by wood-frame bearing walls. The lateral force resisting system consists of wood-framed shear walls. Original drawings of the building were not available. However, we believe the first floor is a concrete slab-on-grade, and the building is most-likely supported on conventional spread footings.

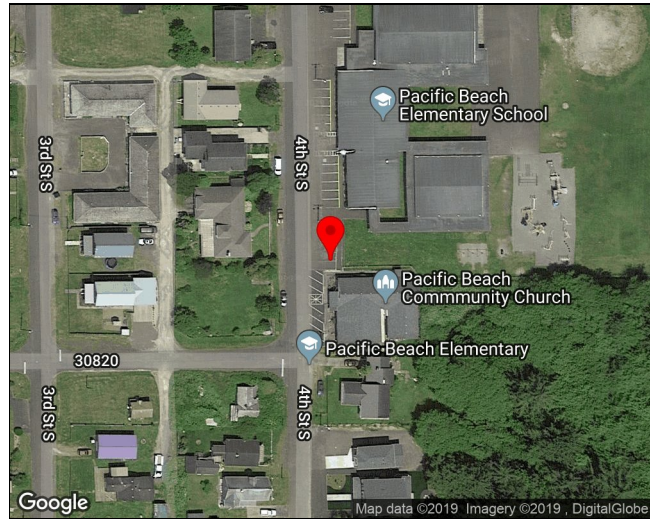
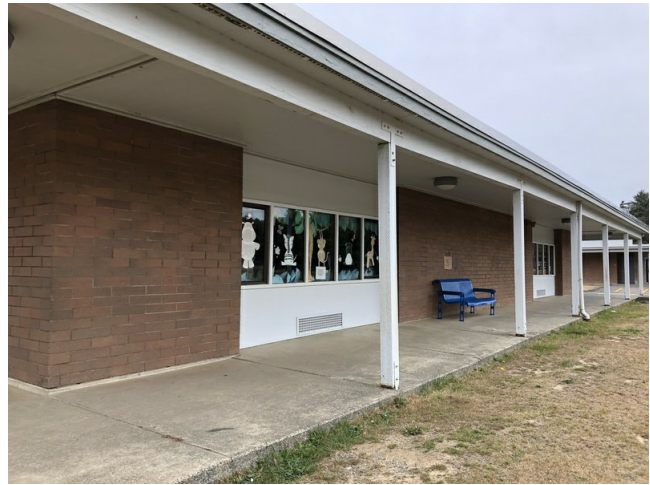
The Quad Building at the Pacific Beach Elementary is located on the southeast corner of the campus. The single-story square building covers a footprint of 70 feet by 75 feet and approximately 5,000 square feet, and contains four equal classrooms that are separated by operable partition walls. The roof structure likely consists of timber framing spanning to the brick masonry bearing walls around the perimeter of the building. Lateral loads are resisted by the brick masonry bearing walls. Original structural drawings were not available for review, but based on a brief walk through we believe the building is supported on conventional spread footings.
